# Active Thermographic Structural Feature Inspection of Wind-Turbine Rotor

<sup>1</sup>University of Applied Sciences Ruhr West, Bottrop Germany

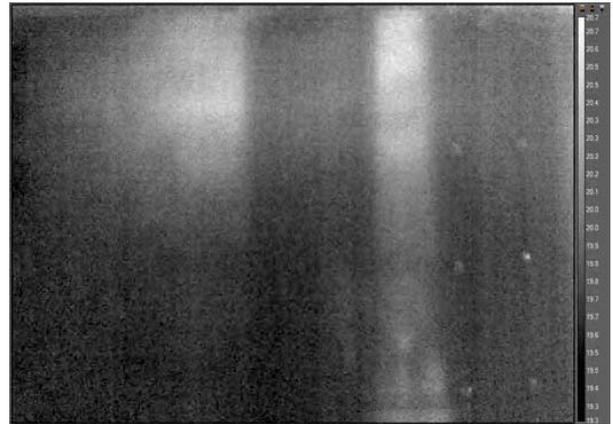
**Figure 4. The blade front before heat source was activated**

As can be seen in Fig. 4, some structural features of the rotor blade already become visible from the slow heating up of the room. If the blade is exposed to an infrared radiator, the contrast increases and additional features are unveiled. In Fig. 5, taken after 10 minutes, the wooden cores can be identified along with some horizontal lines, which most likely are overlapping fiber-mats.

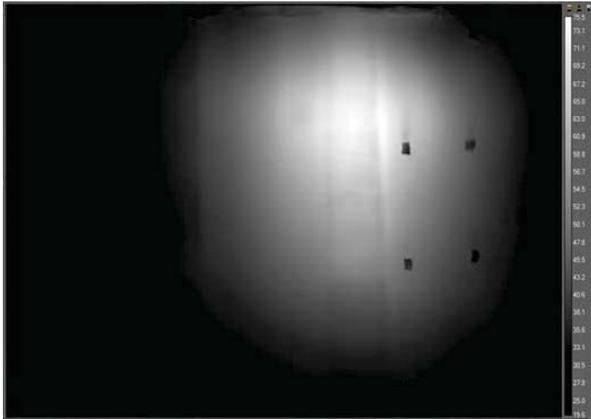
**Figure 6. Begin of cooling process**

At the beginning of the cooling process, the temperature is almost homogeneously distributed over the whole surface (Fig. 6). Afterward the image shows cool areas that are located where the wooden plates are and hot areas that appear where only fiber composite is located.

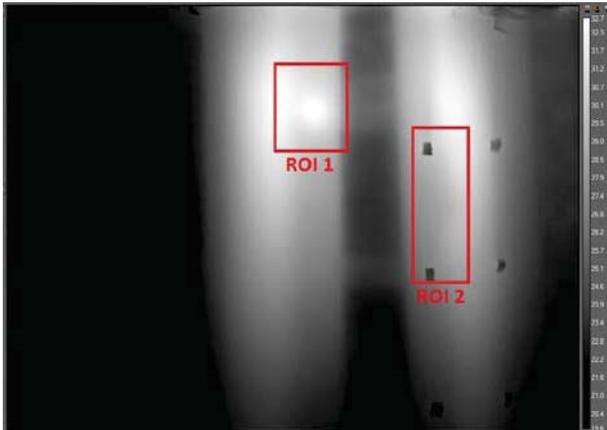
**Figure 7. End of the cooling process**

At the end of the observation period, after about 1 hour of cooling, the initially cooler areas show little contrast while the hot areas have split up into regions, which adapted their temperature differently. Those areas correspond to the structural density of the rotor blade. At the location of the aluminum block, the surface temperature clearly differs from the surrounding area (Fig. 7 ROI 1). The effects of the damaged adhesive joint are less dominant but an anomaly can be seen exactly at its position (Fig. 7 ROI 2).

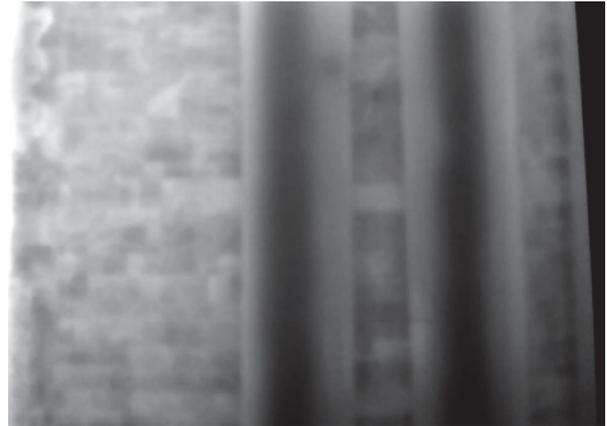
**Figure 8. Heating over shorter time**

Variation of the heating interval has shown that the final results depend on the parameters chosen for heating up the blade. Due to the low thermal conductivity of the materials in the rotor blade, the inner parts of the structure take a long time to heat up. Short heating periods do not completely heat-up the inner parts with a high heat capacity. During the cooling phase, heat from the outer parts is conducted into those still cold structures. Consequently, the temperature contrast is decreased or even inverted compared to longer heating periods. This effect is shown in Fig. 8.

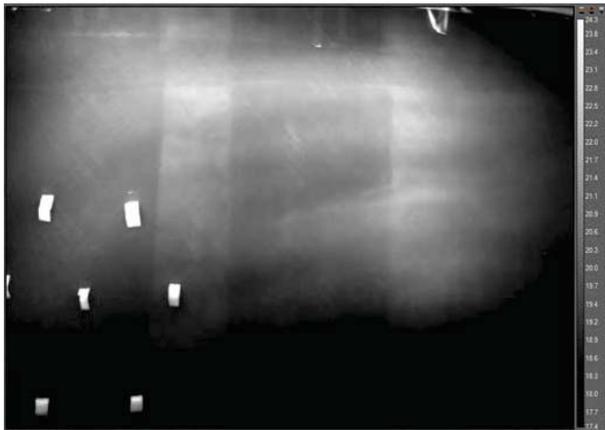
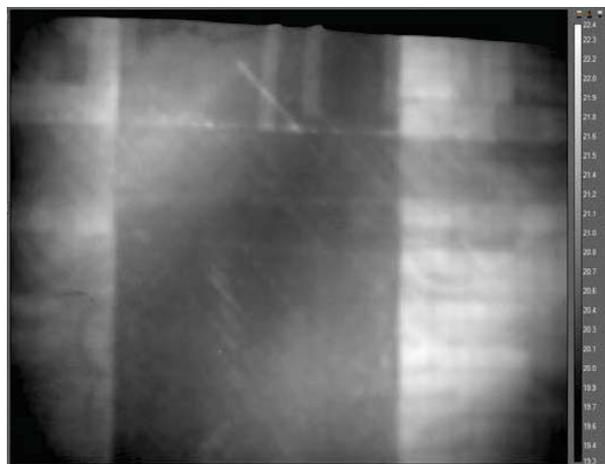
On the other hand, very short heating intervals of less than 1 minute expose structural features right below the surface in fine detail. Fig. 9 and Fig. 10 show this effect. Being taken after an up-heating period of 10-20 seconds, both pictures clearly show structure of the fiber-mats right below the gel coat. On both pictures, the mats are clearly visible in form lines with a course of 45° angle. These are not detectable on the surface by the naked eye. There is also a big horizontal line in both pictures. This big line is probably an area of two overlapping fiber-mats. However, more research needs to be done to clearly classify such structures in the outer layers of the blade and how they can be used for early damage recognition.

The pictures were taken with the Flir A655sc (LWIR) and the Flir A6700sc (MWIR). They show the same region of the blade but were not recorded simultaneously, as the two cameras were not available at the same time. Images from other tests also show comparable results between the two spectral ranges. The thermal sensitivity of the cameras is also of little relevance to the results of this method. The critical areas on the surface were several hundred mK in difference and sometimes far greater than 1 K. Compared to the thermal sensitivity the pixel resolution of the camera is the more important factor, because the higher resolution allows a better detection of small failures in the large blades. Even with significantly worse thermal sensitivity, the same structures can be detected if the picture resolution is high enough.

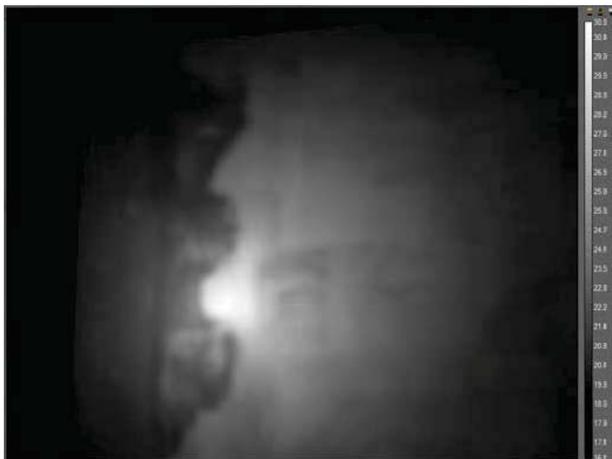
Figure 11. Glue under the surface

Another interesting part of the blade that can be investigated with very short heating times is at the trailing edge. These joints can be seen with less effort as the joints in the middle because the blade is far less thick in these areas.
